# Manhole Inspection Summary

## Manhole # S29KK1019MH

**Location** Address: **4304 NORTHHIELD PL**

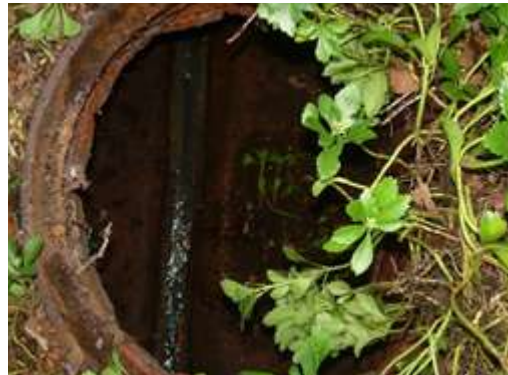
Top View

Evidence of surcharge - Bench debris.

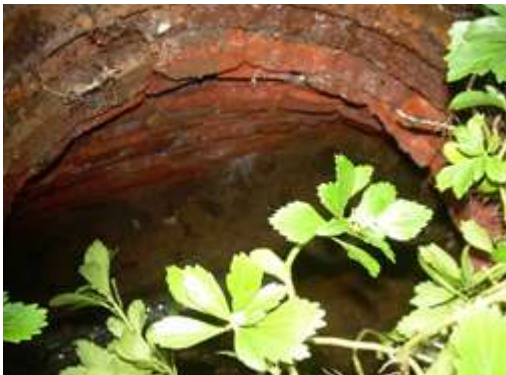
Defect

Corbel deterioration and infiltration. Barrel infiltration.

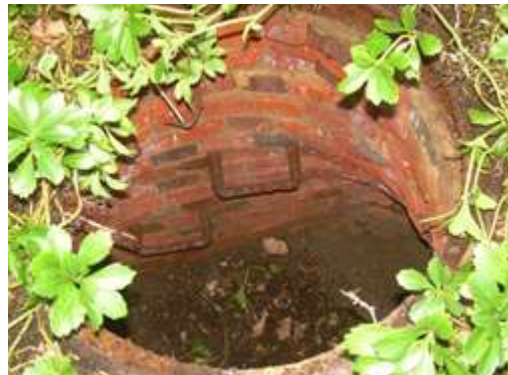
Defect

Corroded and missing steps. Corbel deterioration and infiltration. Barrel infiltration - other side.

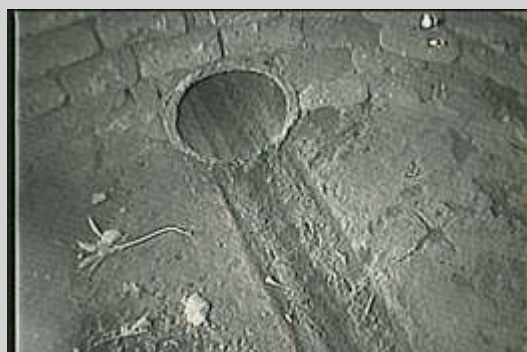
Pipe In @ 6 O'Clock

Barrel deterioration and infiltration.

Infiltration: **Evidence** Pipe Seal Cond: **Unknown**
